1. **Site Address:** Crowndale House, Crowndale Road, Camden, London, NW1 1TP
2. **Project:** Cladding remediation to existing 6 storey block of flats
3. **Inspection Date:** 17/01/2025
4. **Weather:** Overcast
5. **Inspection Number:** 01
6. **Site Contact:** Ben Lockerby (GPF Lewis) – 07840 838 438
7. **Inspection Type:** External Wall Survey

This site inspection note summarises the findings of the site visit that was undertaken on the 17th January 2025. The purpose of the visit was to review the external wall construction. Walked over site with Ben Lockerby (GPF Lewis), Miles Lynch (Create Architects),

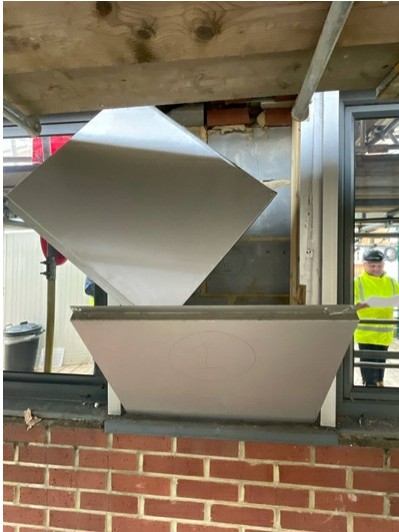
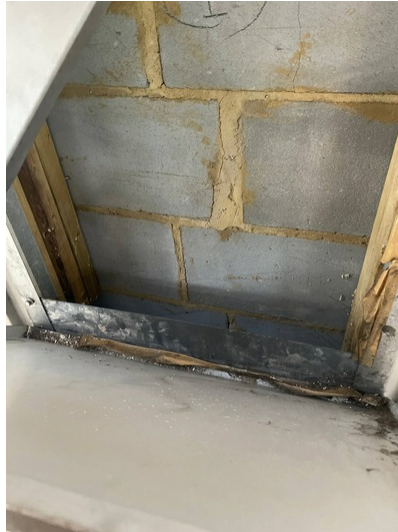
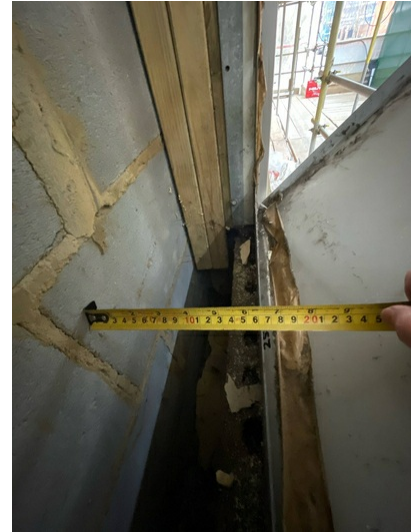
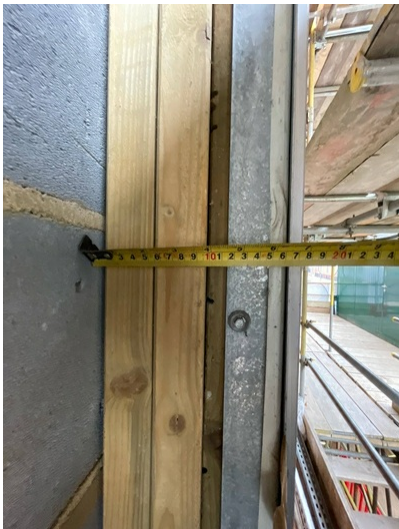
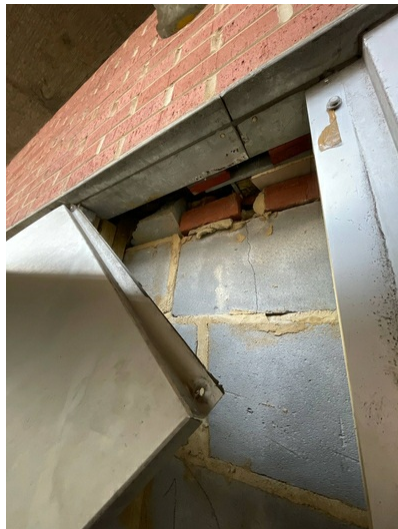
Item: 1

Comment: Opening made by removal of aluminium cladding panel revealing approx. 170mm cavity/void with blockwork inner skin. 2No. timber battens (~45mm thick) in place vertically to window jambs. Site agents advised that windows are fixed through to the timber battens, therefore it has been requested these remain in place - Agreed for timber battens to remain as the proposal is to close the area off with a form of cavity barrier (possibly 12mm cementitious board). Advised horizontal cavity barriers will also be required at the top and bottom to close the edge of the cavity (masonry inner leaf will require some remediation).

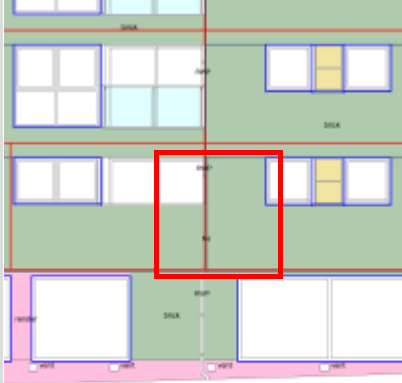
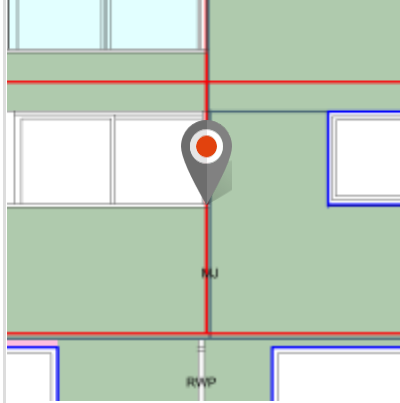
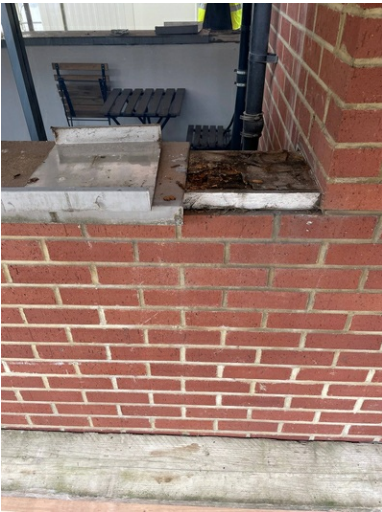
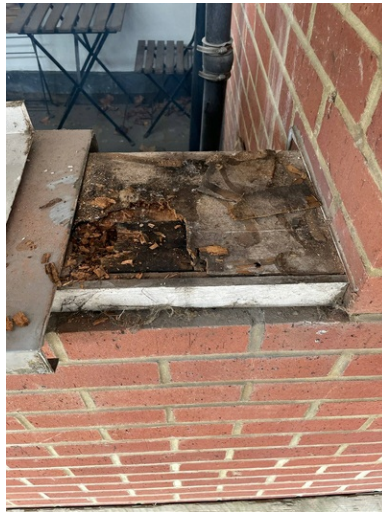
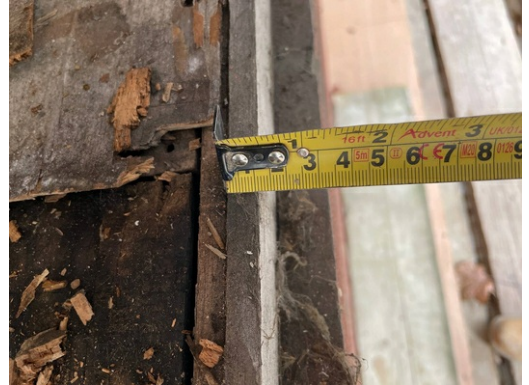
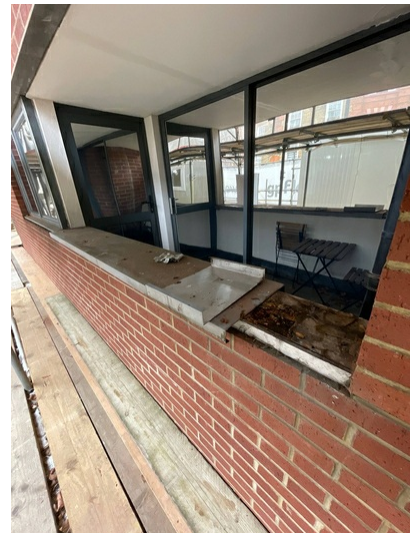
Item: 2**Location:** 1st Floor East Elevation Balcony Parapet**Layer:** 704-CDA-XX-05-DR-A-21-0201-REV 06-EAST ELEVATION

**Status:** Open**Comment:** Timber board is to be removed and replaced with A2 alternative. Proposed architectural detail appears satisfactory.**Photographic Evidence:**

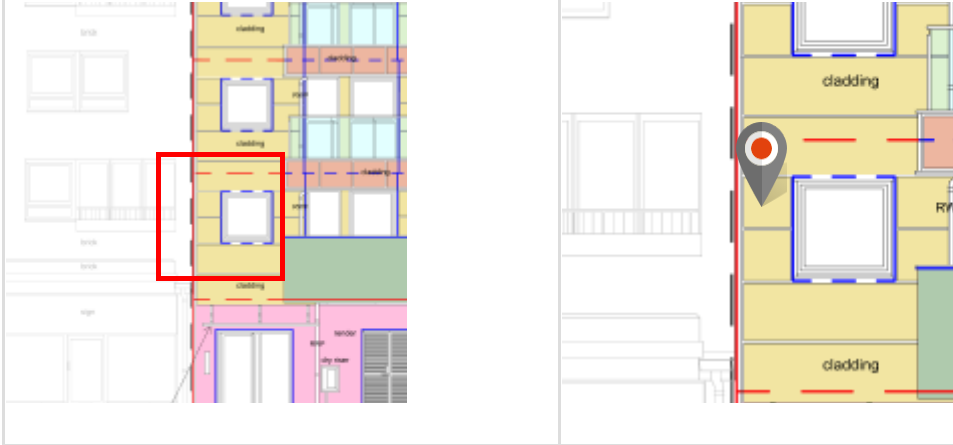
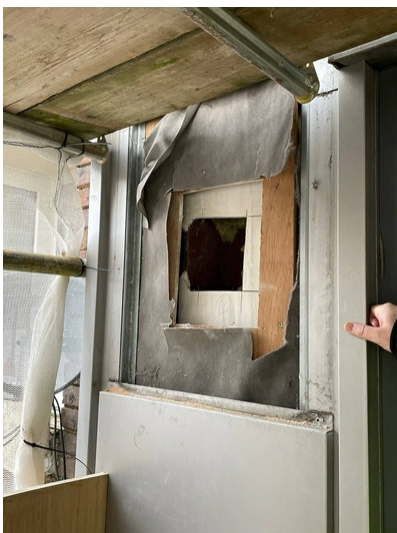
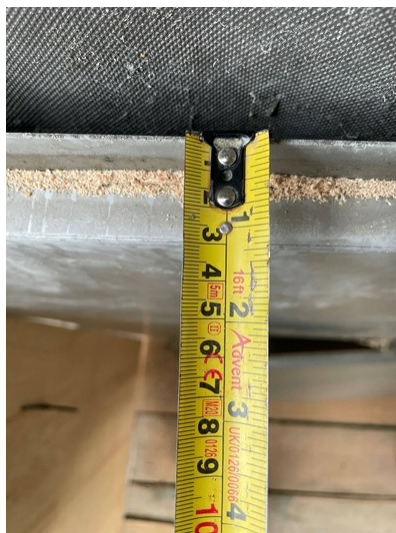
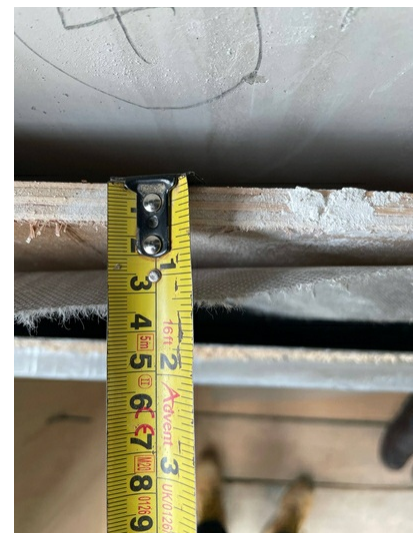
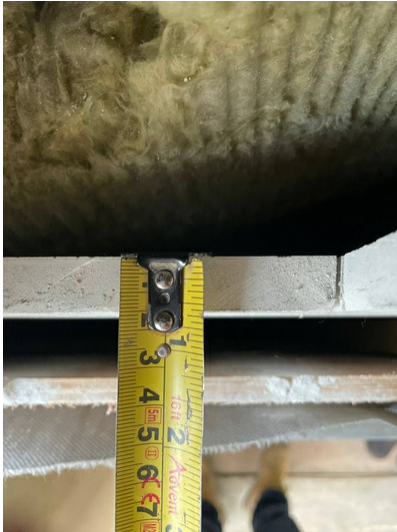
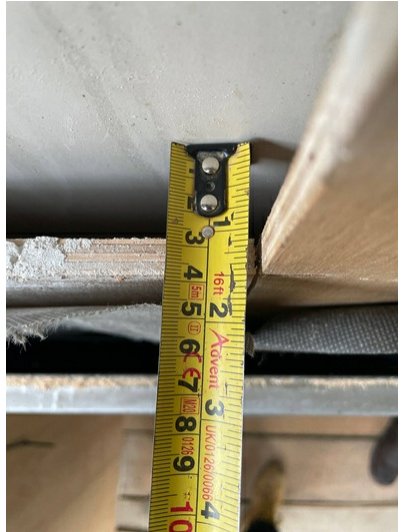
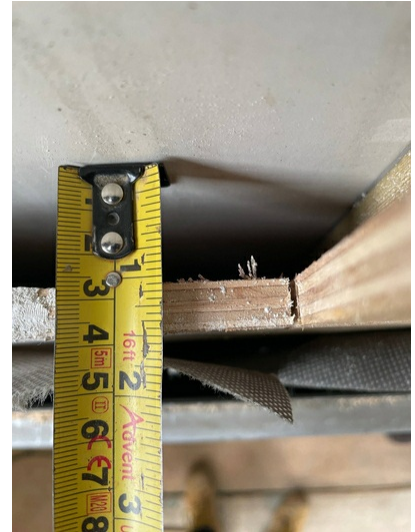
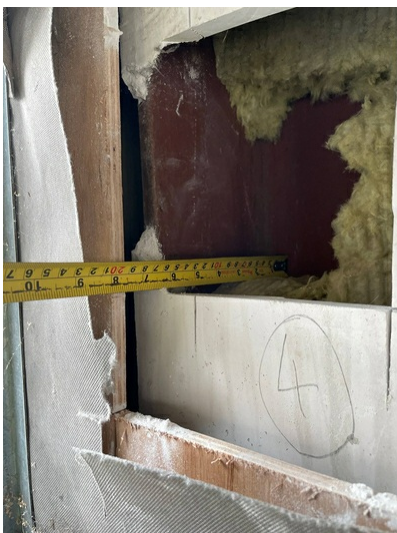
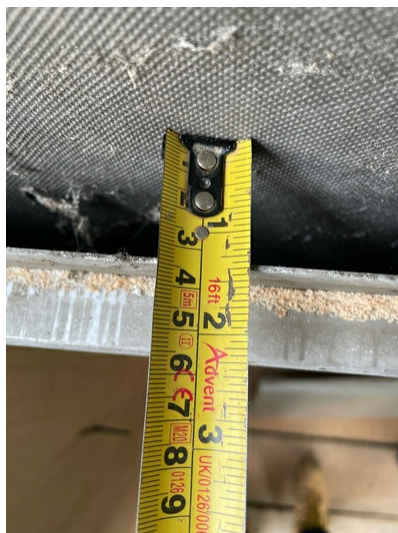
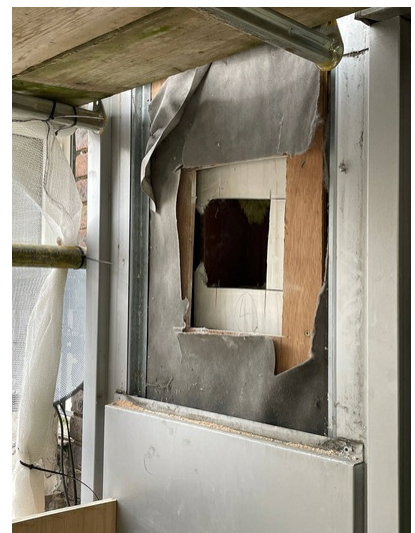
Item: 3

Comment: Opening made through the cladding showing 9mm plywood with breather membrane over. Vertical steel in place with partial fill mineral wool insulation within the web. 12mm white board (unknown product) present over the outer face of the steel (which has been cut to reveal internal build-up). Noted that void behind the white board appears to be free of insulation or vertical cavity barrier to the party wall line. White board also does not return down the steelwork.

Discussed fire protection to steelwork within the cavity. Advised that the exposed face of the steels should be provided, however received further comments from Building Control after the site visit that advised any steelwork (primary structure) should be provided with fire protection as this would be classed as a defect.

Fire protection to the steel structure is to be confirmed. Proposed details indicate partial fill mineral wool insulation to be installed (to replace all existing insulation), along with cavity barriers being installed to compartment wall/floor lines and around openings.

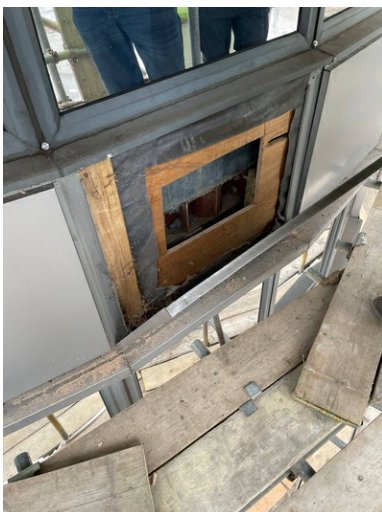
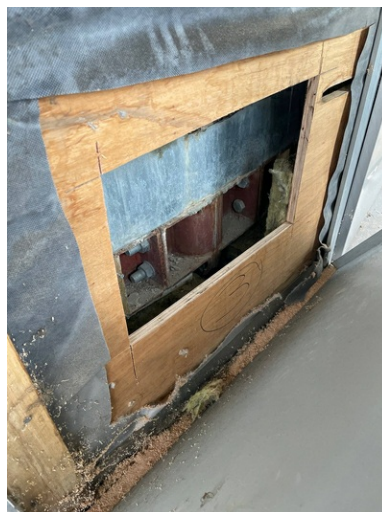
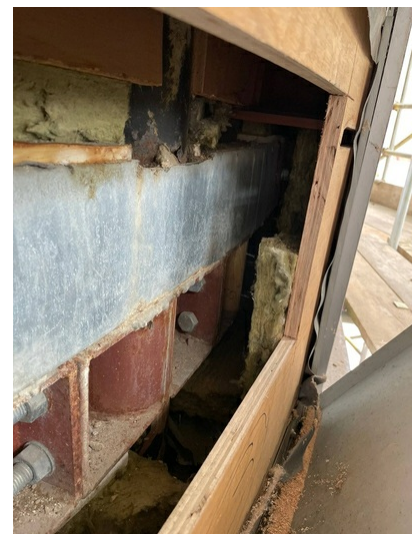
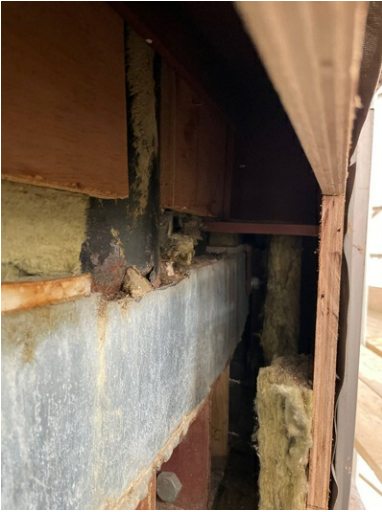
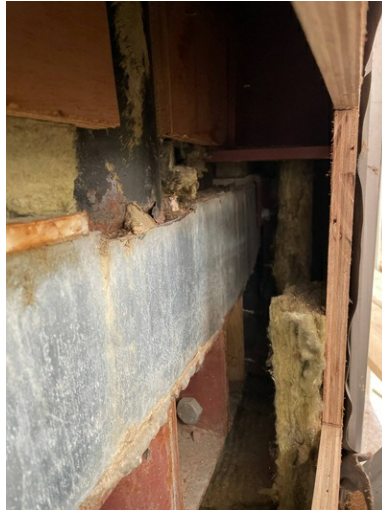
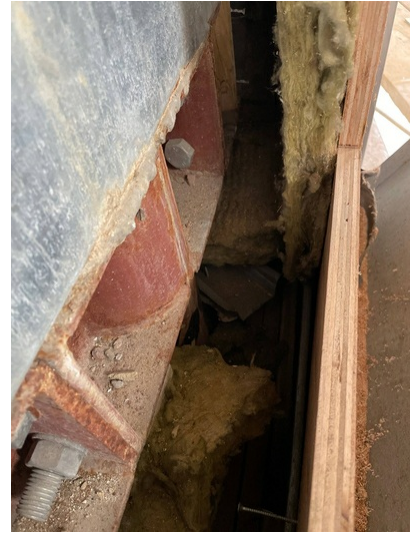
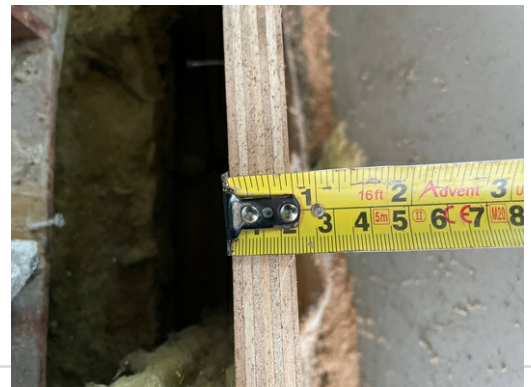
Item: 4

Comment: Cladding panel removed along the compartment floor line. Build-up appears to include grey breather membrane over 18mm plywood with approx. 140mm void behind. Partial fill mineral wool insulation present within the void sporadically located. No cavity barriers could be seen along the compartment floor zone or at the edges of the cavity/above or below the curtain walling system. Steelwork within the void also does not appear to have been provided with any fire protection within the cavity.

Fire protection to the steel structure is to be confirmed. Proposed details indicate partial fill mineral wool insulation to be installed (to replace all existing insulation), along with cavity barriers being installed to the compartment floor.

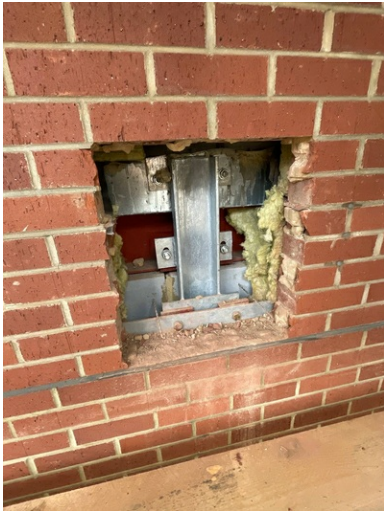
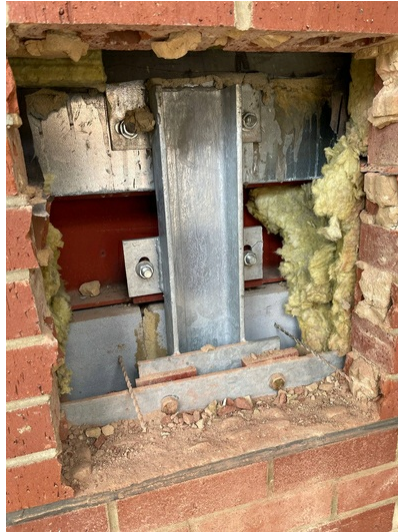
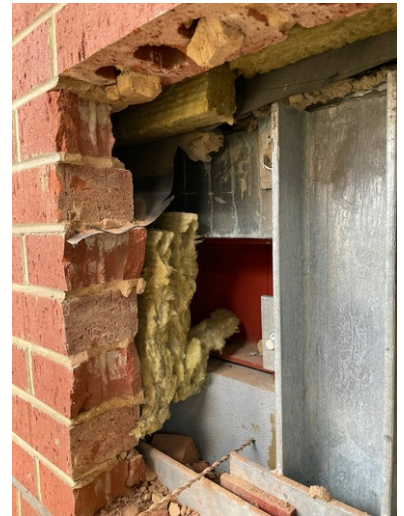
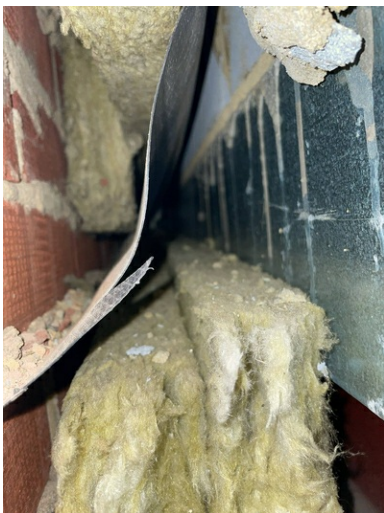
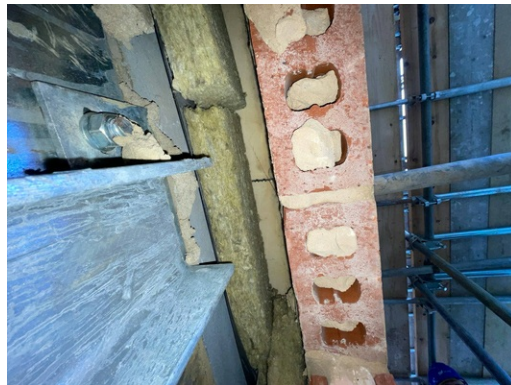
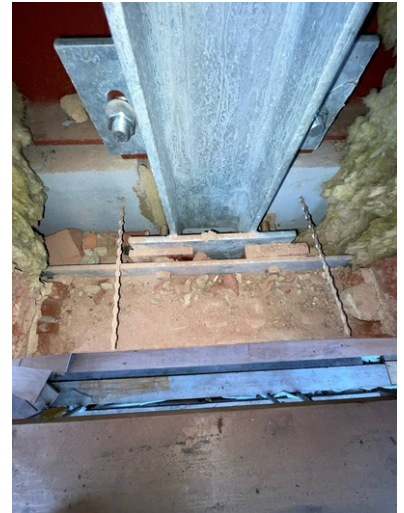
Item: 5

Comment: Opening made through the removal of bricks revealing approx. 110mm cavity and a blockwork inner leaf. Steel I beam present horizontally across the top of the blockwork, with what appears to be a steel windpost present vertically. Neither steel appears to have any fire protection within the cavity, therefore presume suitable protection has been provided from the inside. Insulation within the cavity appears to be a mixture of partial fill mineral wool and PIR/Phenolic insulation.

No cavity barriers were visible to the compartment floor zone, however it is unclear whether the design of the masonry wall is in accordance with the recommendations of ADB diagram 8.2.

Fire protection to the steel structure is to be confirmed. Proposed details indicate partial fill mineral wool insulation to be installed (to replace all existing insulation), along with cavity barriers being installed to compartment wall/floor lines and around openings.

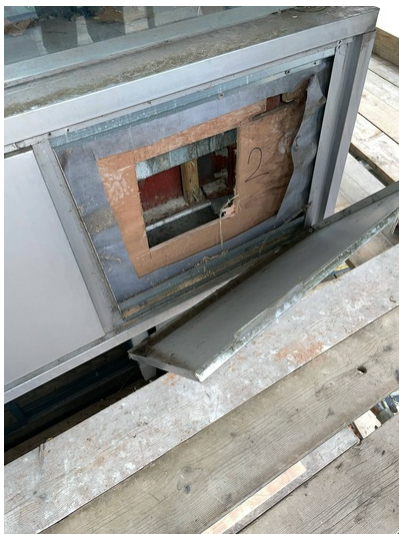
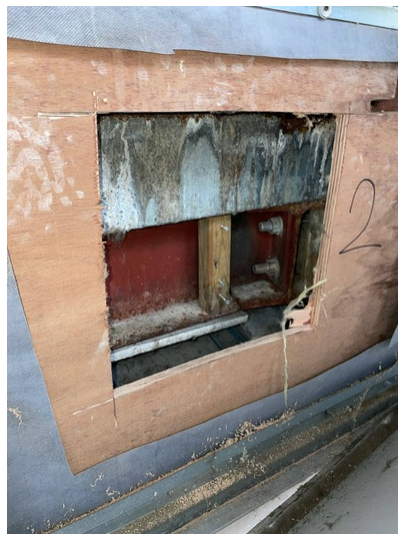
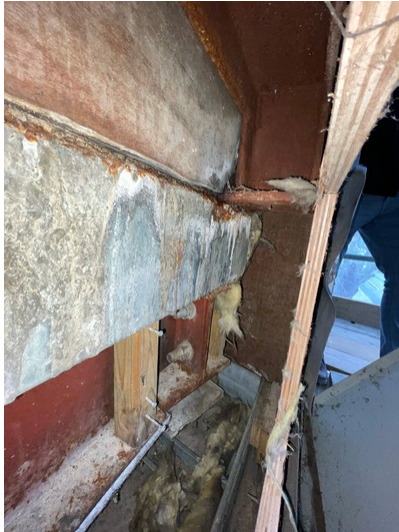
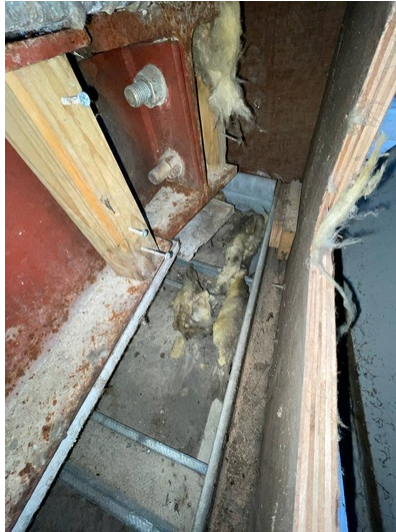
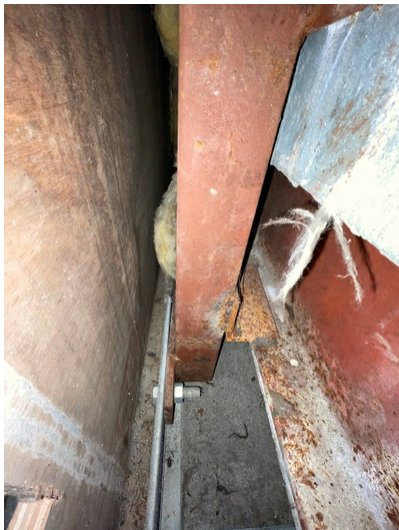
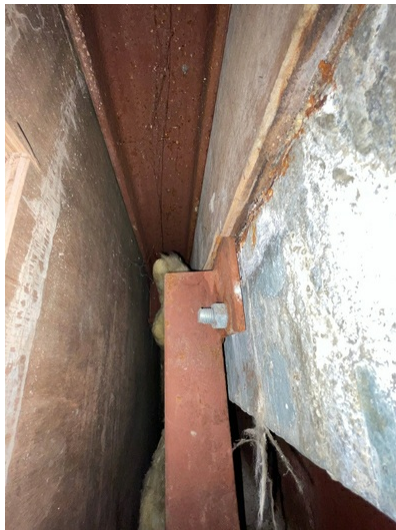
Item: 6

Comment: Cladding panel removed along the compartment floor line. Build-up appears to include grey breather membrane over 18mm plywood with approx. 160mm void behind. Partial fill mineral wool insulation present within the void sporadically located. No cavity barriers could be seen within the void. Steelwork within the void also does not appear to have been provided with any fire protection within the cavity.

Vertical closed state cavity barrier at the edge of the building to separate the balcony.

Horizontal open state cavity barrier required at compartment floor level.

Cavity barriers required vertically and within the cladding at the edge of the building line and horizontally to the compartment floor location between the windows. Balcony structure would not strictly require fire protection due to being external and is not classed as a compartment floor. Recommend this is reviewed with Building Control to confirm acceptability.

Recommend further opening up works are undertaken to assess full as-built scenario.

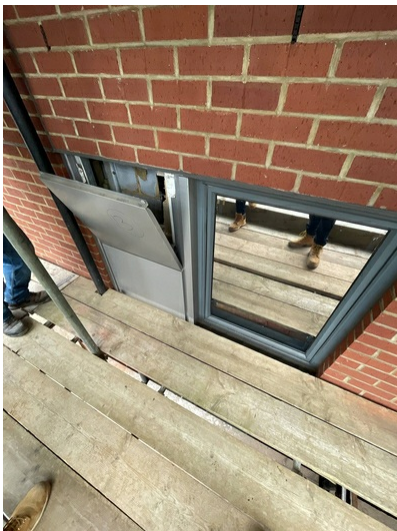
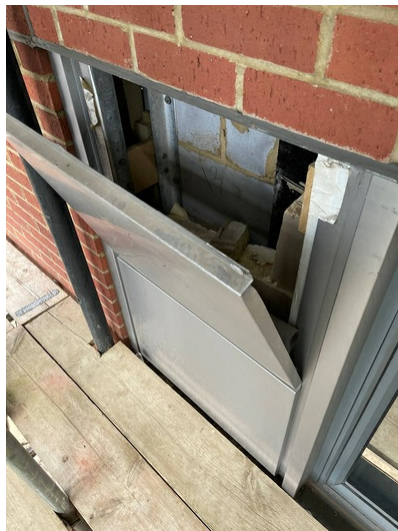
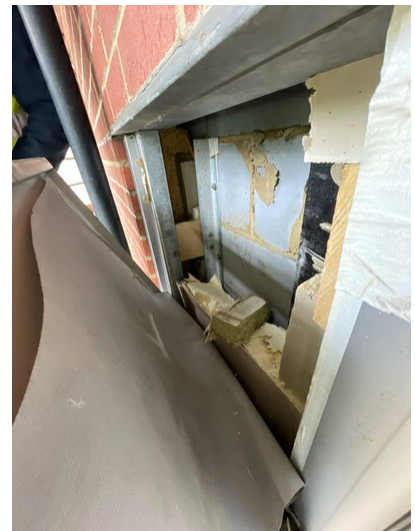
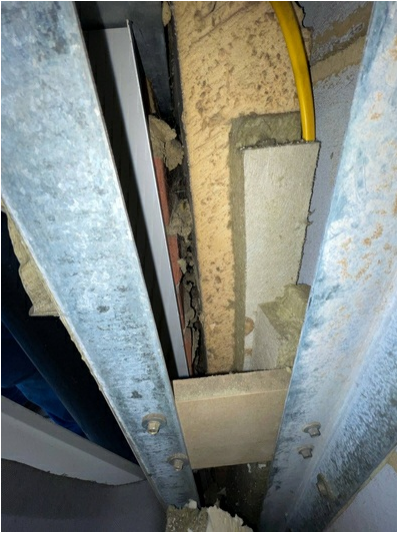
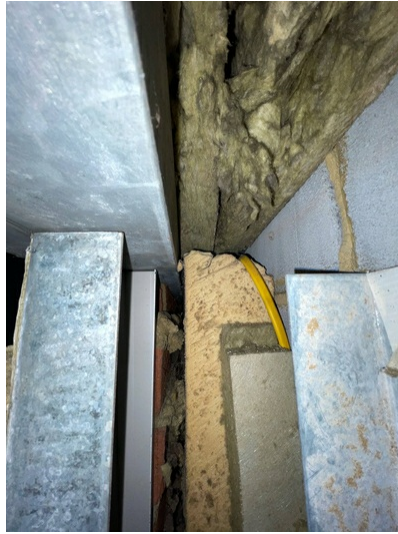
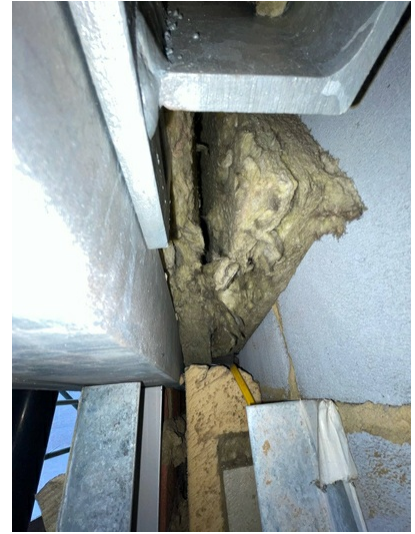
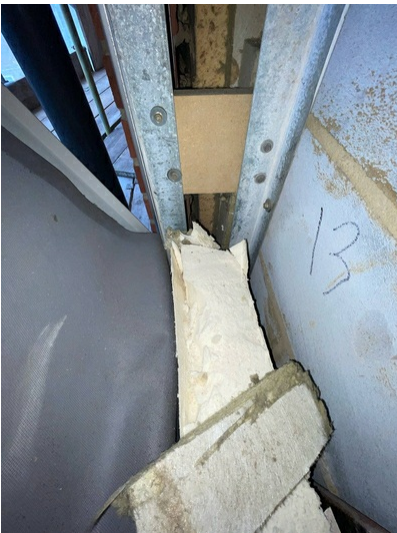
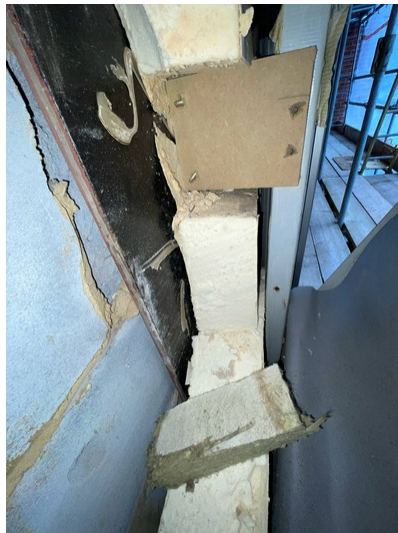
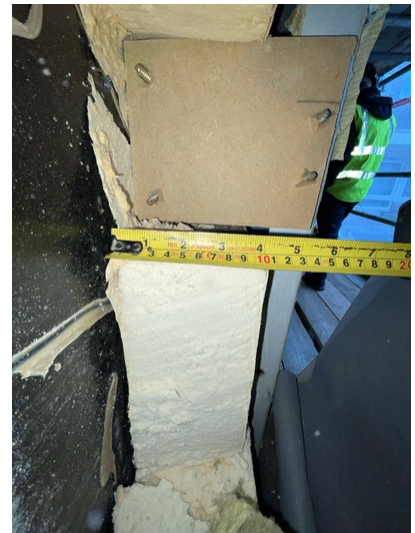
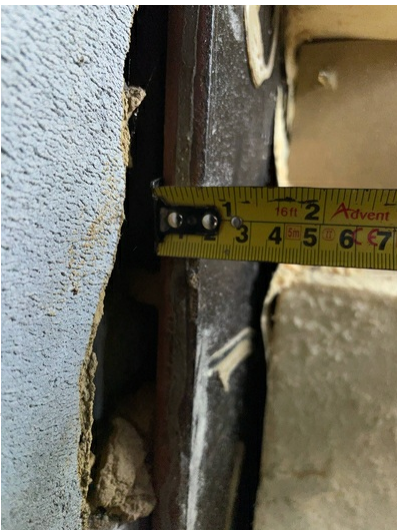
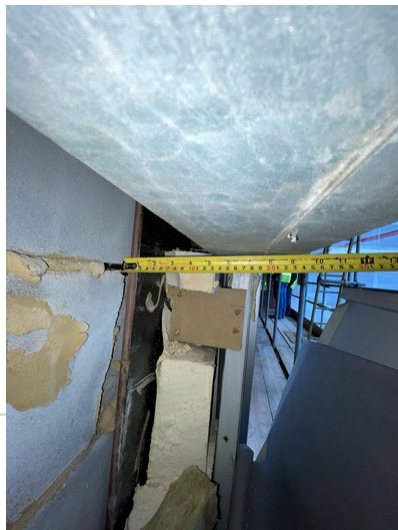
Item: 7

Comment: Opening made by the removal of 1x aluminium cladding panel revealing a grey breather membrane, approx. 190-200mm void, partial fill mineral wool and 100mm PIR insulation, ~12mm plywood and a blockwork inner skin. No cavity barriers could be seen at the edges of the cavity or around the window opening.

Recommend combustible insulation and plywood is removed and replaced with suitable alternatives that achieve a minimum classification to fire of Class A2-s1, d0 when tested in accordance with BS EN 13501-1. Cavity barriers are also to be installed around the window opening as per the proposed design.

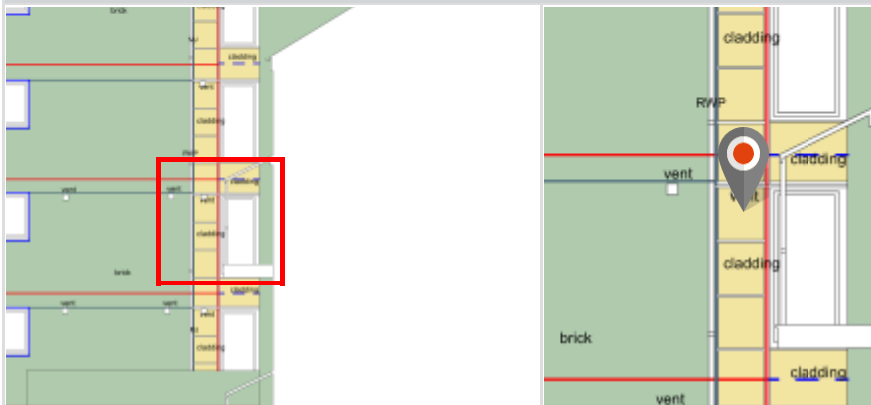
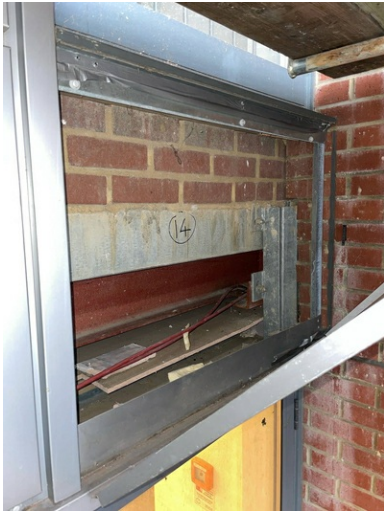
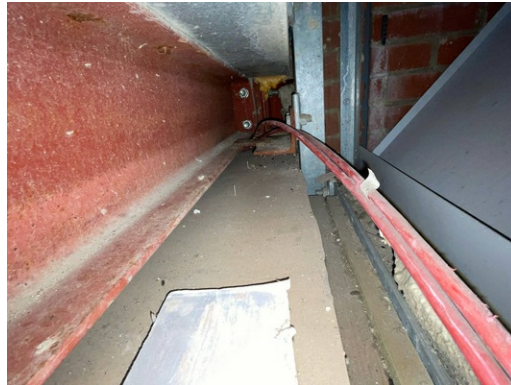
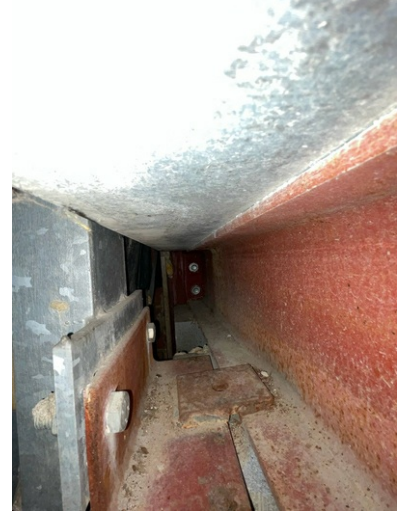
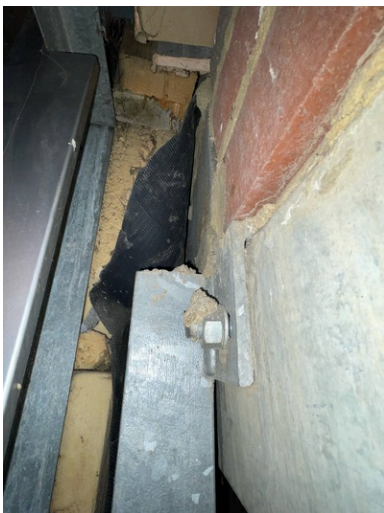
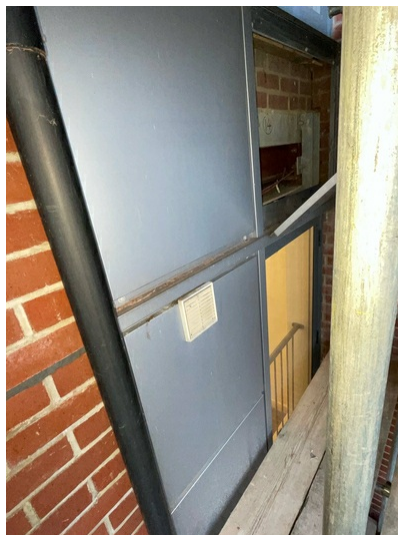
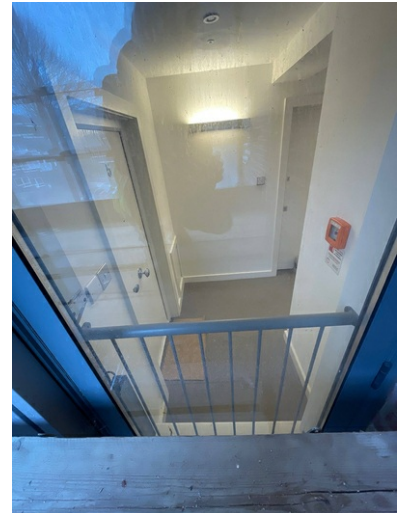
Item: 8

Comment: Opening made by removal of an aluminium cladding panel revealing an empty void with steelwork and electrical cables present. Brickwork inner leaf present. No vertical compartmentation appears to be present between the corridor and the flat within the wall and likewise, no horizontal cavity barrier appears to be present to the slab level behind the cladding.

Phenolic/PIR insulation appears to be present behind the adjacent brickwork outer leaf.

Fire protection to the steel structure is to be confirmed. Proposed details indicate partial fill mineral wool insulation to be installed (to replace all existing insulation), along with cavity barriers being installed to compartment wall/floor lines and around openings.

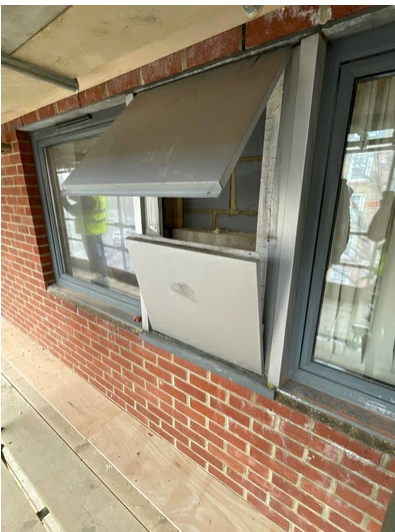
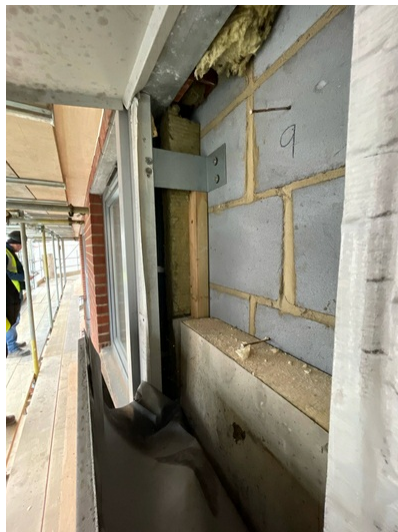
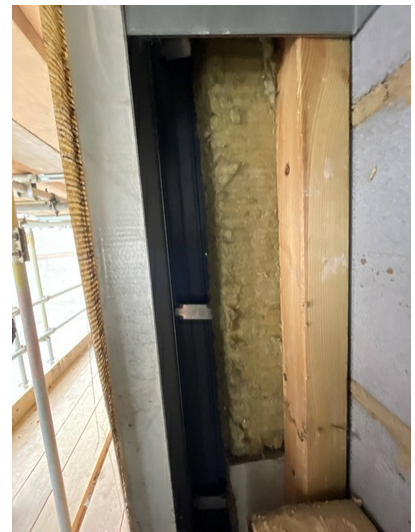
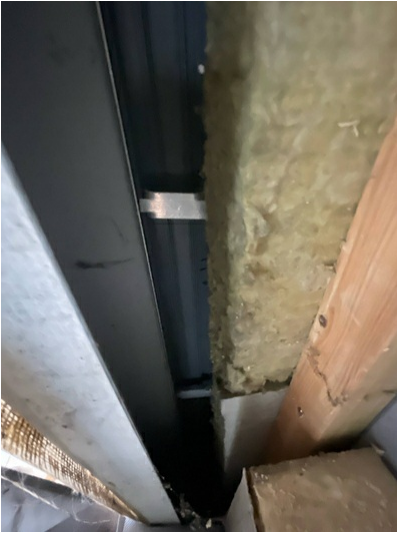
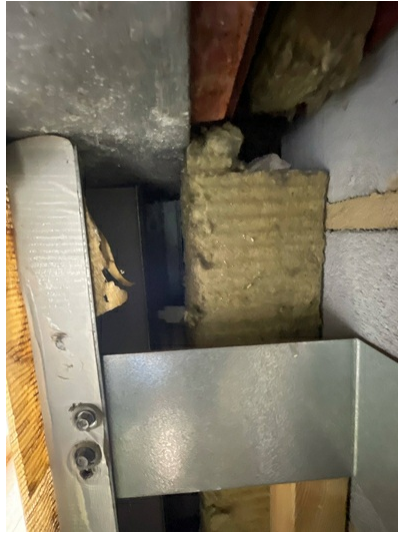
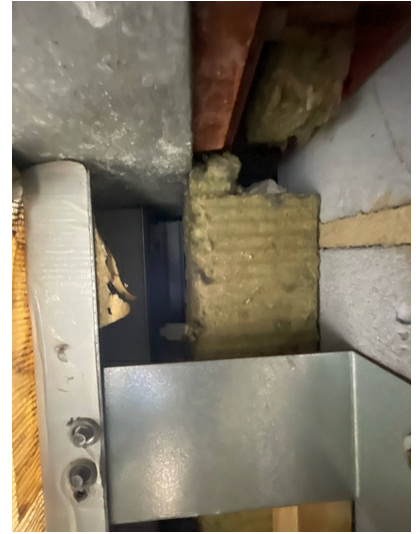
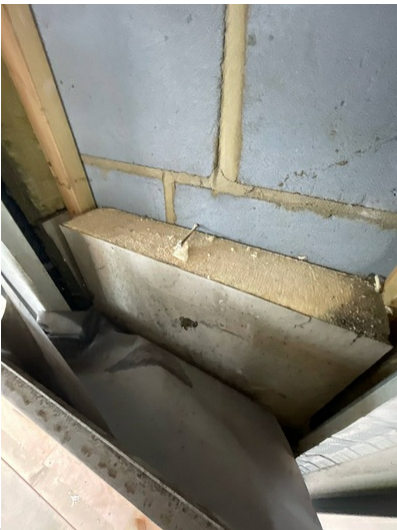
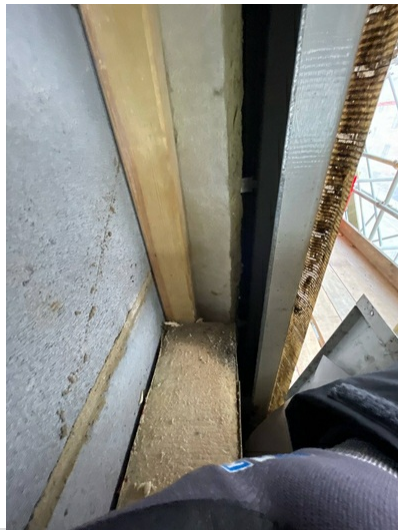
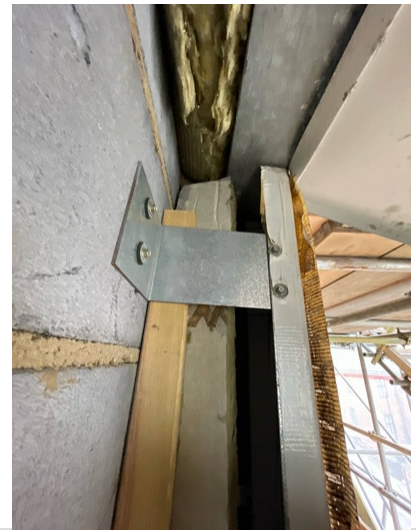
Item: 9

Comment: Opening provided by removal of aluminium cladding panel revealing partial fill mineral wool/PIR insulation and blockwork inner leaf. Edges of the window frames appear to be present exposed within the cavity with no closer or cavity barriers present around the window.

Window frames can be seen. No fire protection or weather protection. Pir insulation present

Fire protection to the steel structure is to be confirmed. Proposed details indicate partial fill mineral wool insulation to be installed (to replace all existing insulation), along with cavity barriers being installed to compartment wall/floor lines and around openings.
