1. **Site Address:** Crowndale House, Crowndale Road, Camden, London, NW1 1TP
2. **Project:** Cladding remediation to existing 6 storey block of flats
3. **Inspection Date:** 17/01/2025
4. **Weather:** Overcast
5. **Inspection Number:** 01
6. **Site Contact:** Ben Lockerby (GPF Lewis) – 07840 838 438
7. **Inspection Type:** External Wall Survey

This site inspection note summarises the findings of the site visit that was undertaken on the 17th January 2025. The purpose of the visit was to review the external wall construction. Walked over site with Ben Lockerby (GPF Lewis), Miles Lynch (Create Architects),

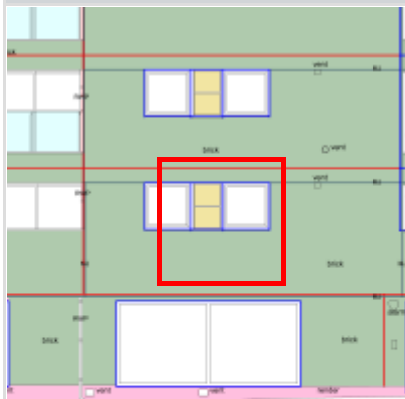
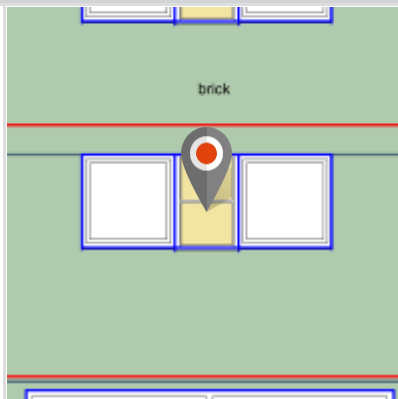
Location: 1st Floor East Elevation Cladding In-Fill Between Windows

Comment: Opening made by removal of aluminium cladding panel revealing approx. 170mm cavity/void with blockwork inner skin. 2No. timber battens (~45mm thick) in place vertically to window jambs. Site agents advised that windows are fixed through to the timber battens, therefore it has been requested these remain in place - Agreed for timber battens to remain as the proposal is to close the area off with a form of cavity barrier (possibly 12mm cementitious board). Advised horizontal cavity barriers will also be required at the top and bottom to close the edge of the cavity (masonry inner leaf will require some remediation).

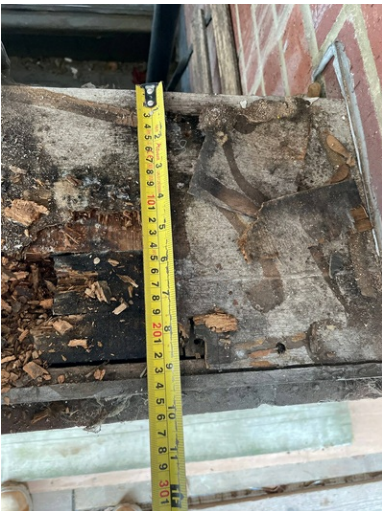
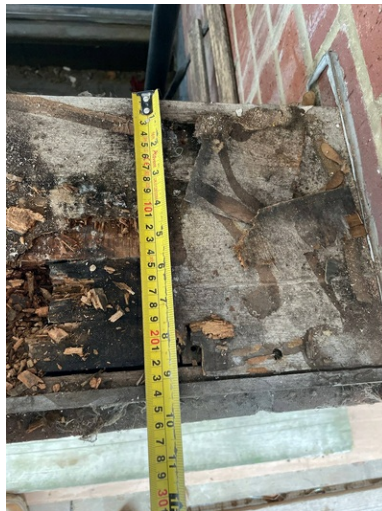
**Status:** Open**Comment:** Timber board is to be removed and replaced with A2 alternative. Proposed architectural detail appears satisfactory.**Photographic Evidence:**

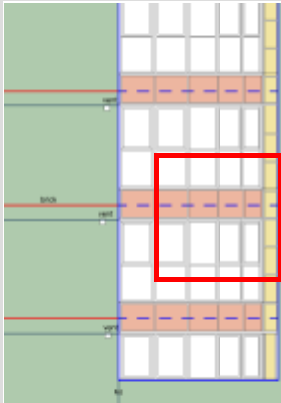
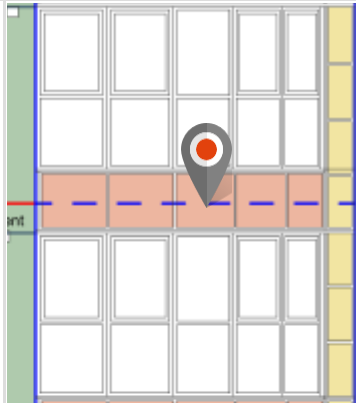
Location: 2nd Floor South Elevation Cladding Between Curtain Walling

Comment: Cladding panel removed along the compartment floor line. Build-up appears to include grey breather membrane over 18mm plywood with approx. 140mm void behind. Partial fill mineral wool insulation present within the void sporadically located. No cavity barriers could be seen along the compartment floor zone or at the edges of the cavity/above or below the curtain walling system. Steelwork within the void also does not appear to have been provided with any fire protection within the cavity.

Fire protection to the steel structure is to be confirmed. Proposed details indicate partial fill mineral wool insulation to be installed (to replace all existing insulation), along with cavity barriers being installed to the compartment floor.

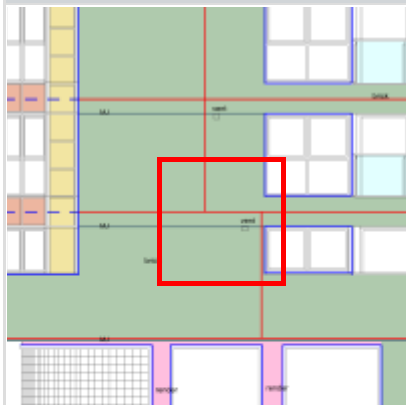
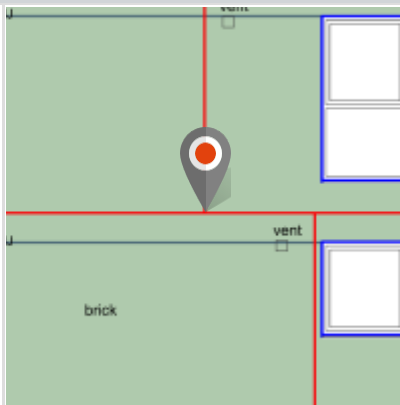
Location: 2nd Floor East Elevation Brickwork

Comment: Opening made through the removal of bricks revealing approx. 110mm cavity and a blockwork inner leaf. Steel I beam present horizontally across the top of the blockwork, with what appears to be a steel windpost present vertically. Neither steel appears to have any fire protection within the cavity, therefore presume suitable protection has been provided from the inside. Insulation within the cavity appears to be a mixture of partial fill mineral wool and PIR/Phenolic insulation.

No cavity barriers were visible to the compartment floor zone, however it is unclear whether the design of the masonry wall is in accordance with the recommendations of ADB diagram 8.2.

Fire protection to the steel structure is to be confirmed. Proposed details indicate partial fill mineral wool insulation to be installed (to replace all existing insulation), along with cavity barriers being installed to compartment wall/floor lines and around openings.

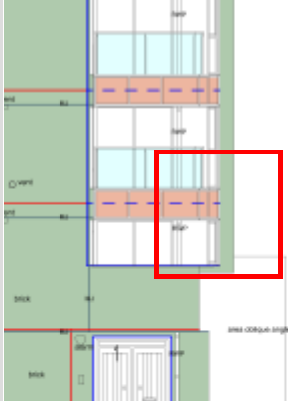
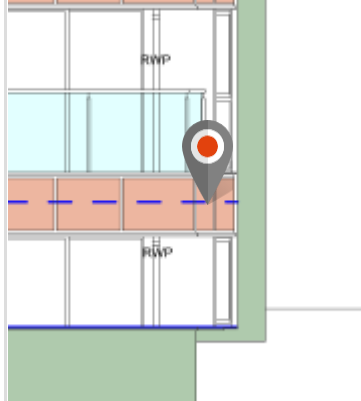
Location: 2nd Floor South Elevation Balcony

Comment: Cladding panel removed along the compartment floor line. Build-up appears to include grey breather membrane over 18mm plywood with approx. 160mm void behind. Partial fill mineral wool insulation present within the void sporadically located. No cavity barriers could be seen within the void. Steelwork within the void also does not appear to have been provided with any fire protection within the cavity.

Cavity barriers required vertically and within the cladding at the edge of the building line and horizontally to the compartment floor location between the windows. Balcony structure would not strictly require fire protection due to being external and is not classed as a compartment floor. Recommend this is reviewed with Building Control to confirm acceptability.

Recommend further opening up works are undertaken to assess full as-built scenario.

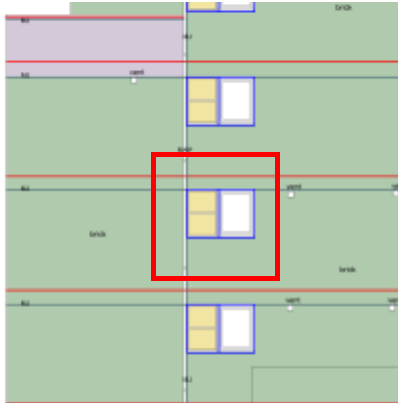
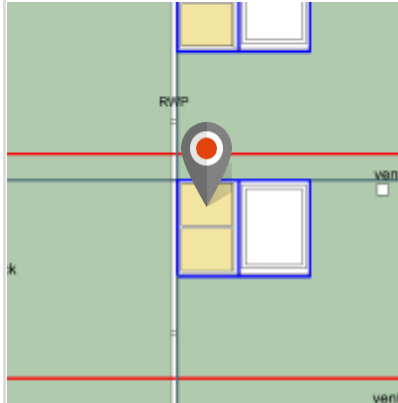
Location: 3rd Floor West Elevation Cladding to Window

Comment: Opening made by the removal of 1x aluminium cladding panel revealing a grey breather membrane, approx. 190-200mm void, partial fill mineral wool and 100mm PIR insulation, ~12mm plywood and a blockwork inner skin. No cavity barriers could be seen at the edges of the cavity or around the window opening.

Recommend combustible insulation and plywood is removed and replaced with suitable alternatives that achieve a minimum classification to fire of Class A2-s1, d0 when tested in accordance with BS EN 13501-1. Cavity barriers are also to be installed around the window opening as per the proposed design.

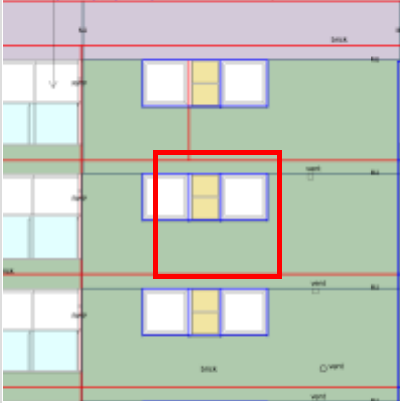
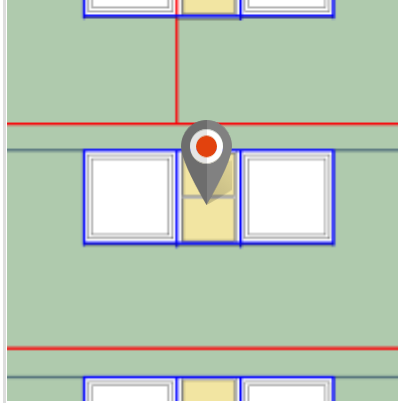
Location: 3rd Floor East Elevation Cladding In-Fill Between Windows

Comment: Opening provided by removal of aluminium cladding panel revealing partial fill mineral wool/PIR insulation and blockwork inner leaf. Edges of the window frames appear to be present exposed within the cavity with no closer or cavity barriers present around the window.

Fire protection to the steel structure is to be confirmed. Proposed details indicate partial fill mineral wool insulation to be installed (to replace all existing insulation), along with cavity barriers being installed to compartment wall/floor lines and around openings.

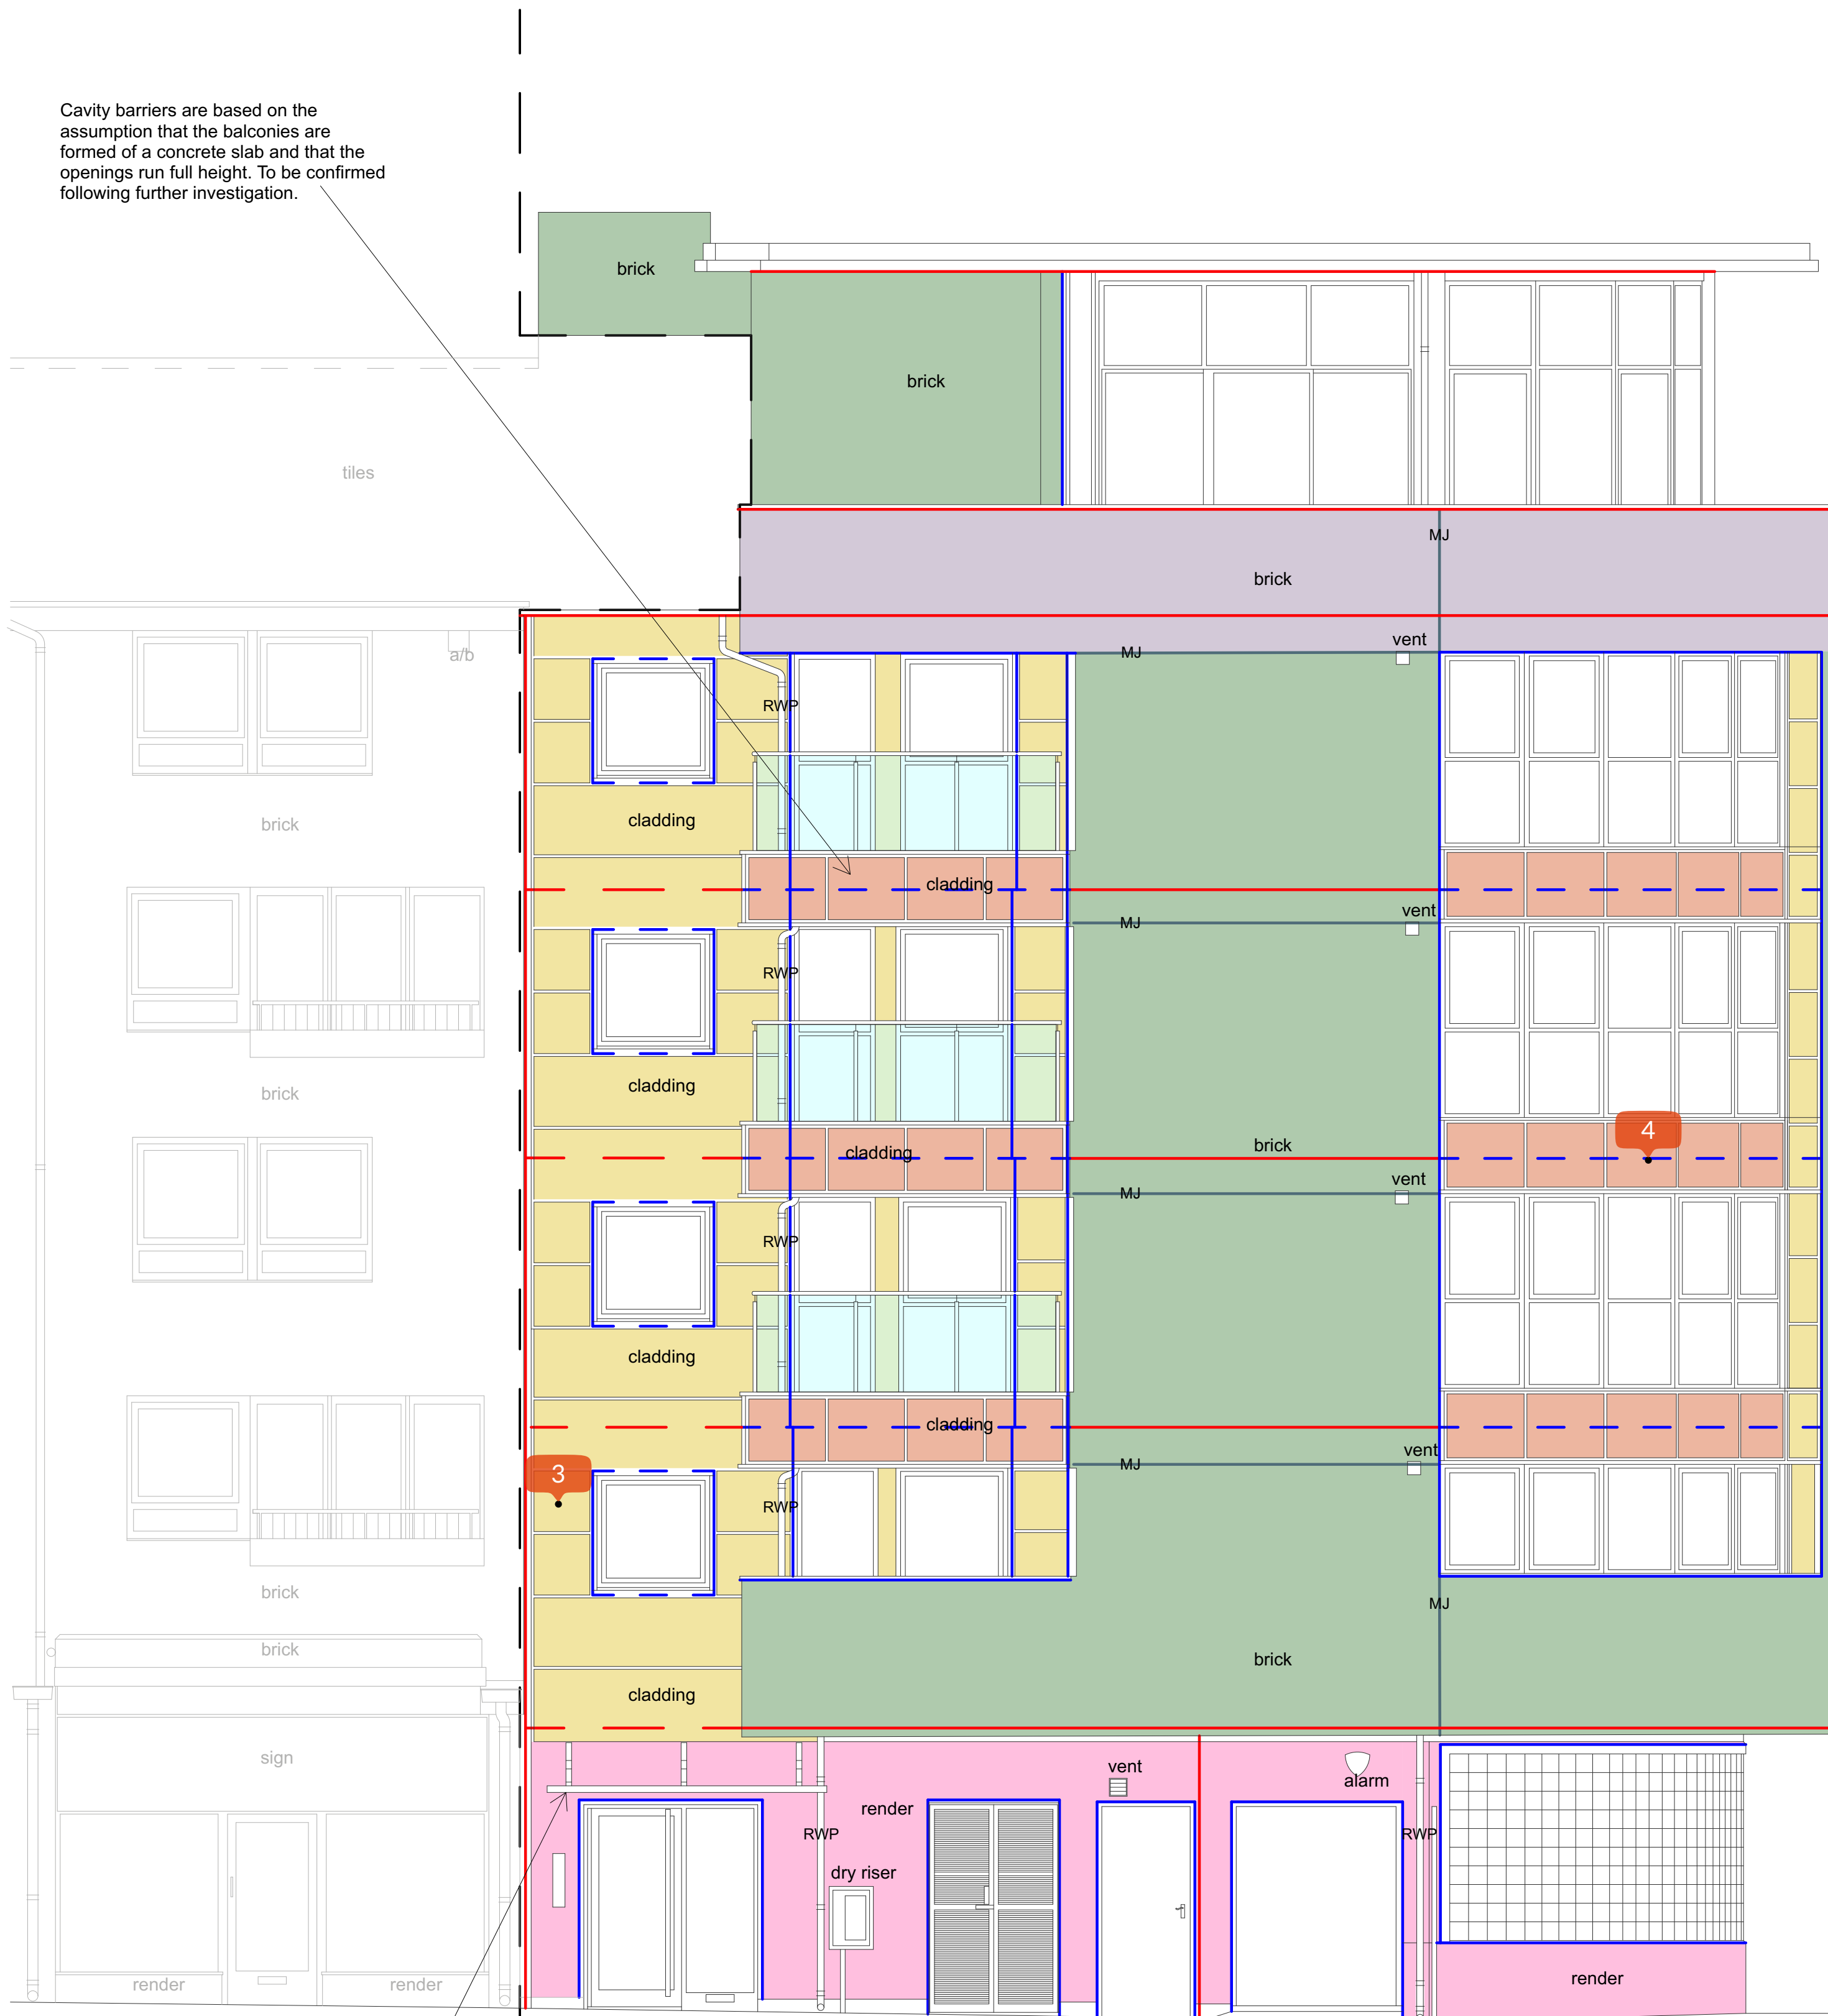
Cavity barriers are based on the assumption that the balconies are formed of a concrete slab and that the openings run full height. To be confirmed following further investigation.

canopy to be removed and refixed, extended fixing brackets may be required. Render will be thicker than the timber panel
